OCCURRENCE OF LINEARS IN THE TUCSON SOUTH QUADRANGLE,  
PIMA COUNTY, ARIZONA

James E. Sherman and Allen W. Hatheway

Department of Mining and Geological Engineering,  
University of Arizona

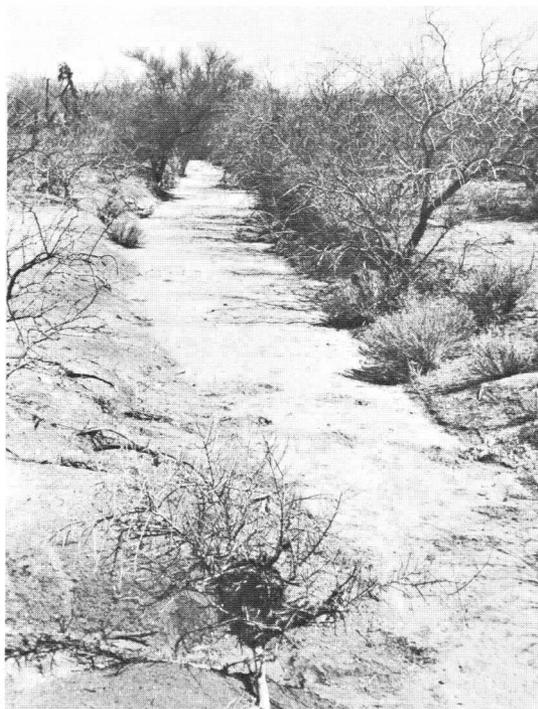
The most common surface expressions of the linears are gullies ranging from 3 to 5 feet in width and from 1-1/2 to 2 feet in depth (fig. 1).

Figure 1. --Typical surface expression of the linears.

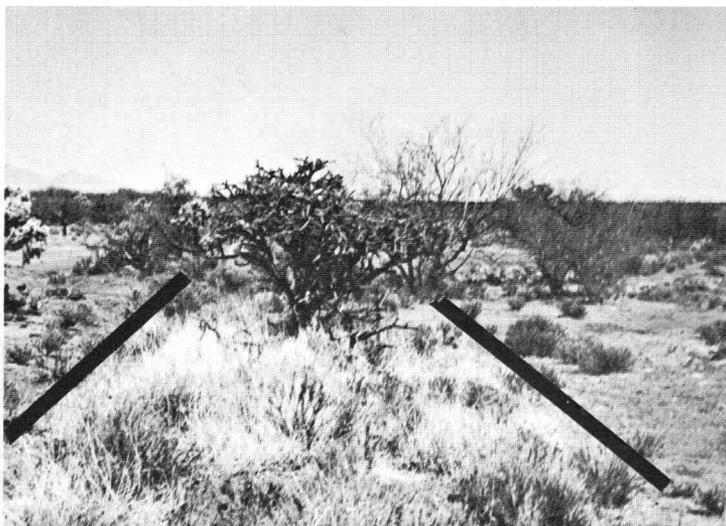
In those areas that lack the necessary gradient to develop differential erosion, the traces are marked by a concentrated growth of vegetation. Such vegetation is usually more dense than that flanking the linears (fig. 2).

Where the linears are not marked by gullies, they are made up of a thick growth of alkali grass of from 6 to 10 feet in width. The effect of this grass in marking the trace of the features is accentuated by the absence of vegetation on the flanks of the linears (fig. 2). Other varieties of plants that are generally concentrated along the traces are sage, mesquite, palo verde, cat's claw, and cholla.

Figure 2. --Alkali grass marking the trace of a linear in the absence of a gully feature. (Black lines denote width of the linear.)

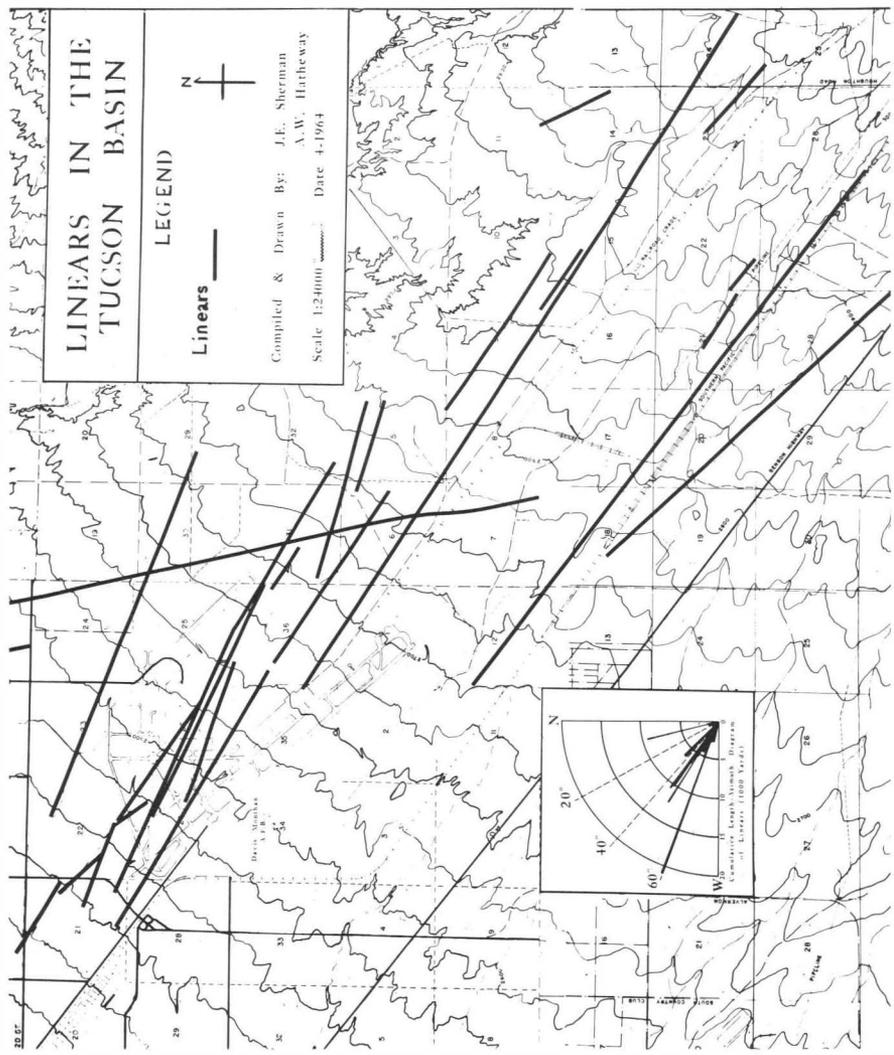
The extent of the linears is shown on figure 3 and represents locations plotted from aerial photographs. Cultural features, such as railroads and highways, are generally parallel to the linears, which lie in a band about 5 miles in width and 12 miles in length. The most dense occurrence of linears occurs within the confines of the Davis-Monthan Military Reservation.

Figure 3. --Linears in the Tucson basin.
