FIELD GUIDE TO  
EARTH FISSURES AND OTHER  
LAND SUBSIDENCE FEATURES  
IN PICACHO BASIN

*Arizona Geological Society*  
*Arizona Hydrological Society*  
Fall 1999 Field Trip  
November 13, 1999

Arizona Geological Survey  
Open-File Report 99-26

Leader:  
Raymond C. Harris  
*Arizona Geological Survey*

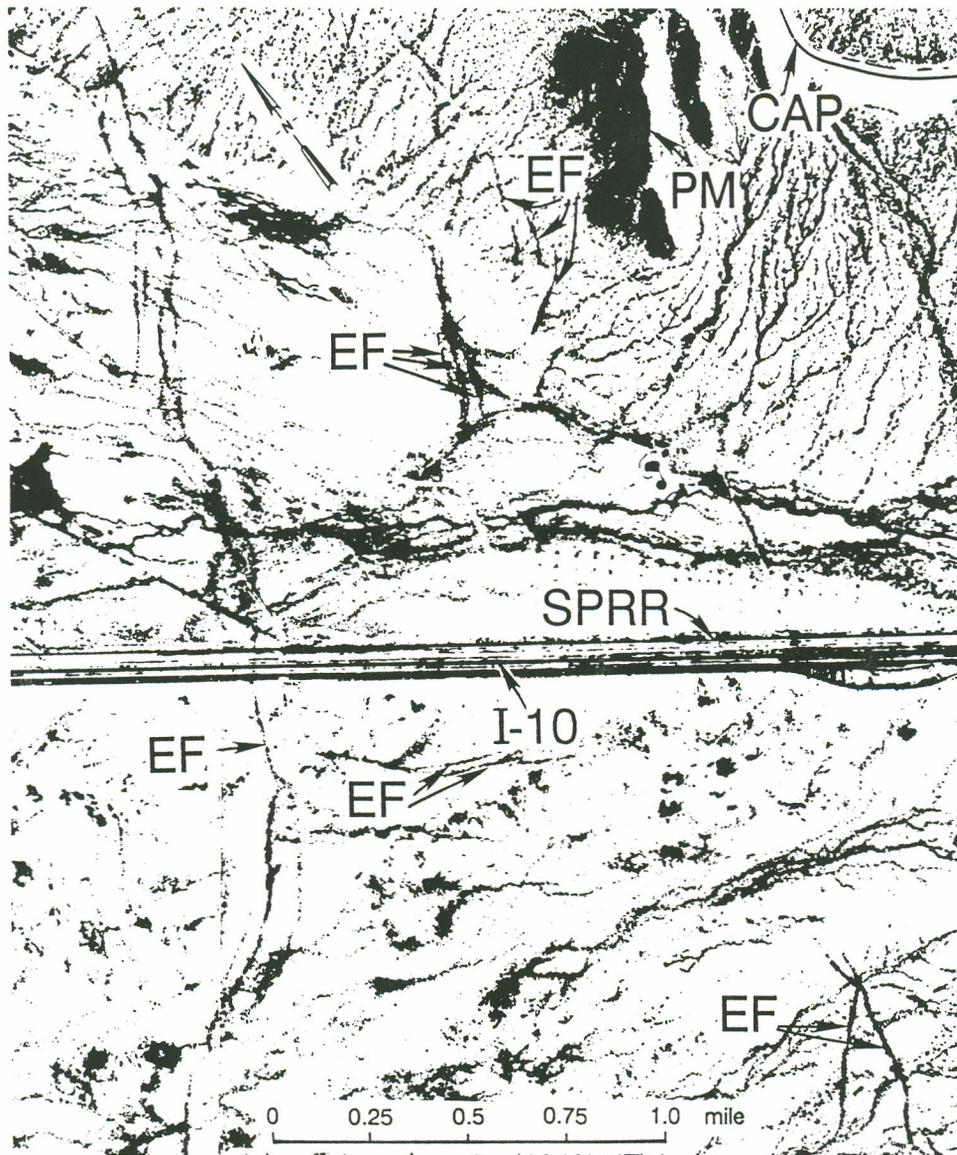
**4.5 33.5** Picacho earth fissure ("El Grande") crosses freeway, approximately milepost 215.3 (**Figure 1**). The fissure runs adjacent to the water tank on a small tower just north of the freeway. Where the fissure crosses the highway there is a noticeable dip in the road that marks the vertical offset of the fissure.

This fissure system, nearly 10 miles long, is the longest in Arizona. It forms a system of multiple, en echelon cracks with a surface expression up to 50 feet wide and 60 feet deep (Slaff, 1989). Opening in 1927, the fissure system has the distinction of being Arizona's first.

**Figure 1. Earth fissure crossing Interstate 10.** Earth fissures, marked 'EF' in the air photo, have formed in numerous areas in the eastern Picacho basin. The long earth fissure on the left side of the photo is known as "El Grande" and where it crosses Interstate 10 there is a noticeable drop-off. Symbols are as follows: EF = earth fissures; I-10 = Interstate 10; SPRR = Southern Pacific Railroad tracks; PM = Picacho Mountains; CAP = Central Arizona Project canal. Figure modified from Slaff (1989); Air photo by Arizona Department of Transportation, 1987.

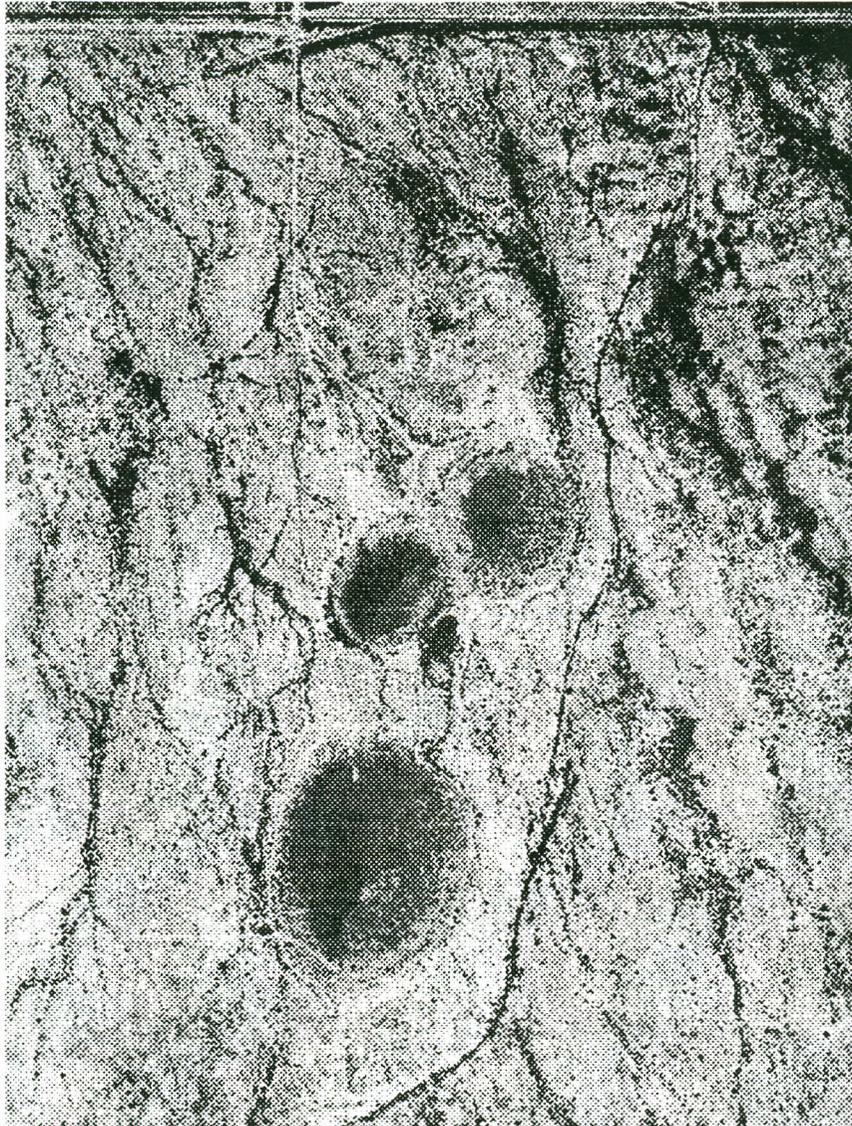
**Figure 3. Aerial view of earth fissures around the Tator Hills, southwest Picacho Basin.** Fissures have formed on both sides of the hills. The fissure zone to the east (right) of the hills is over a mile long. The fissure continues past the bottom of this aerial photo several hundred yards. Photo is about 1.1 miles from top to bottom. (*Aerial photo from Pinal County.*)

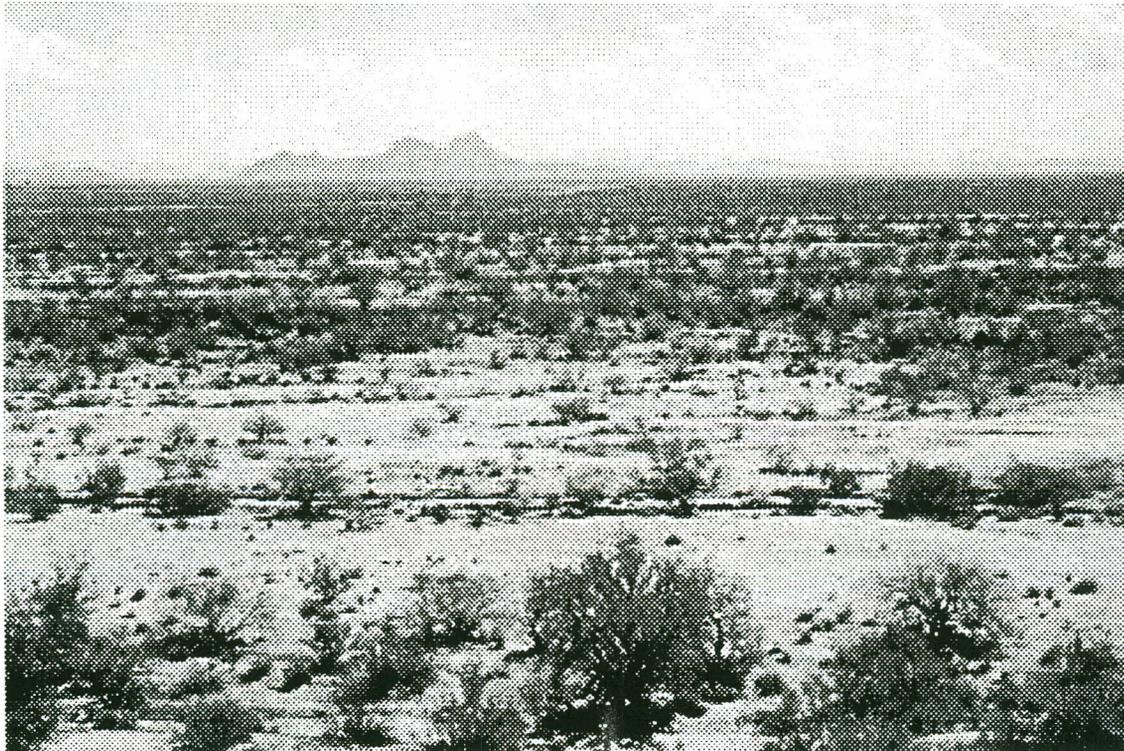
**Figure 4. View of large earth fissure zone on east side of Tator Hills.** Fissure zone here consists of two parallel cracks (horizontal lines about one-third up from bottom of photo). *(Photo by R.C. Harris.)*

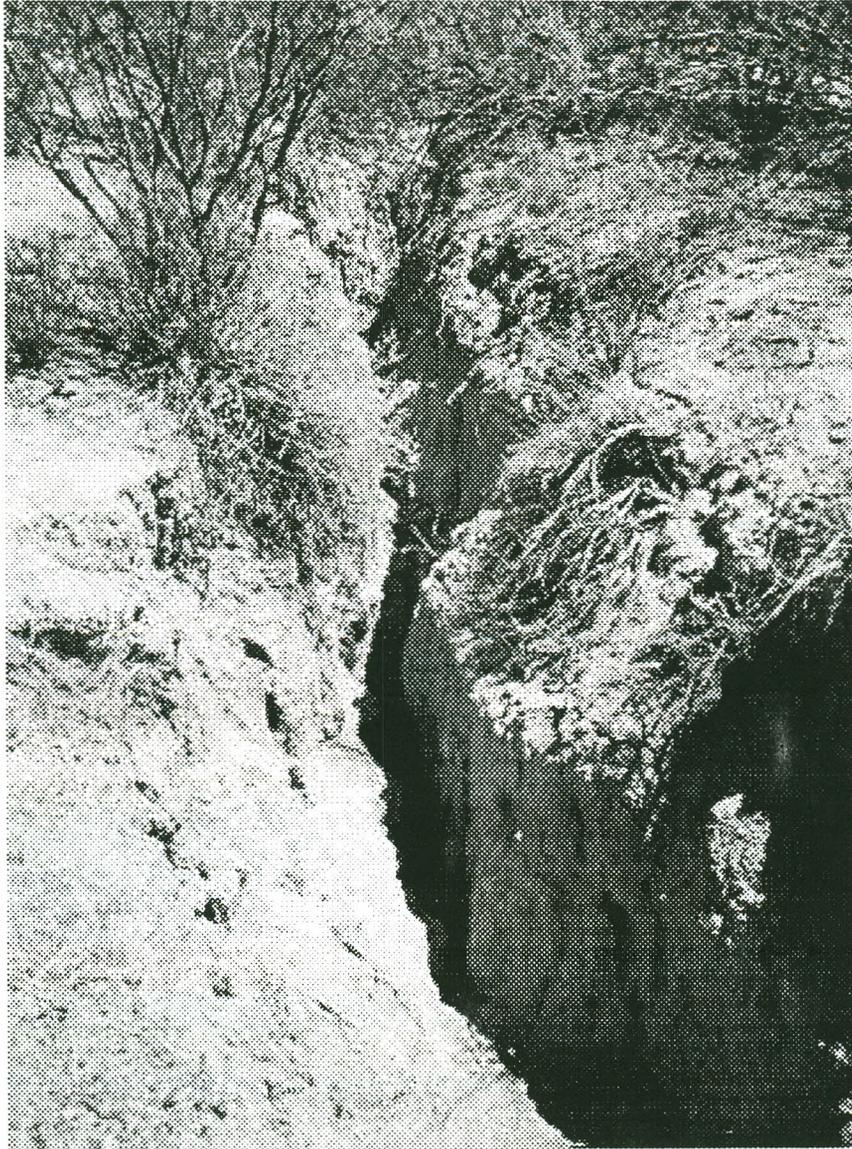
Although the older fissures formed prior to 1977, they are still active, as indicated by their steep sides and highly variable depth (**Figure 6**). In many places the fissure bottom drops out and is too deep to see. To the east of the main fissure(s) are younger cracks just beginning to open. These younger fissures are more discontinuous along their length and are not as deep. Some are not much more than alignments of small depressions or narrow cracks. Even these incipient cracks are usually marked by a line of vegetation, which is often the first sign of a developing fissure.

**Figure 6. Large earth fissure.** Crack here is 3-4 feet wide, up to 15 feet deep. *(Photo by R.C. Harris.)*

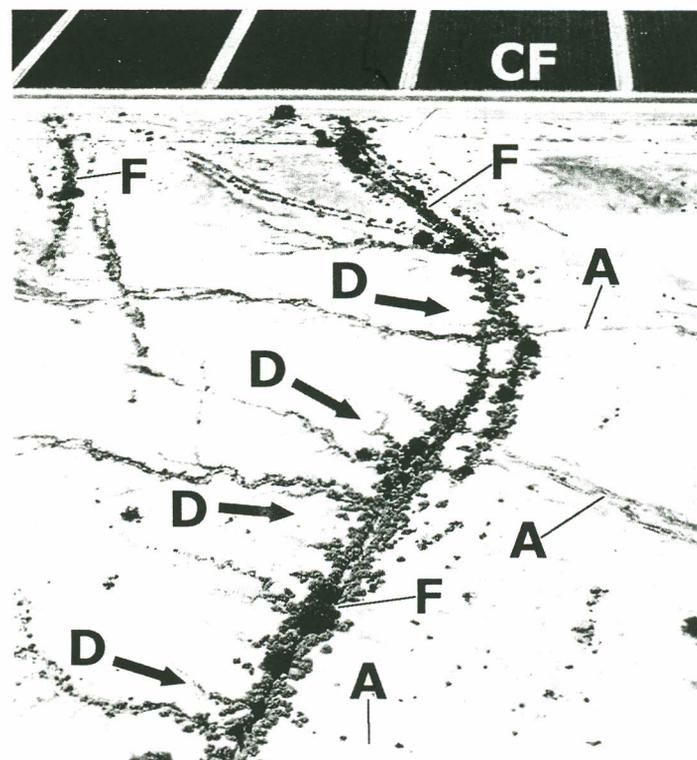
Figure 1. Fissures (F), which appear to stop at the edge of irrigated cotton fields (CF) southeast of Casa Grande in Pinal County, developed at right angles to existing stream channels. After heavy rainfall, runoff drains in the direction of the arrows (D) into the fissures. Channels on the right side of the fissures have been abandoned (A). Photograph by L. D. Fellows.

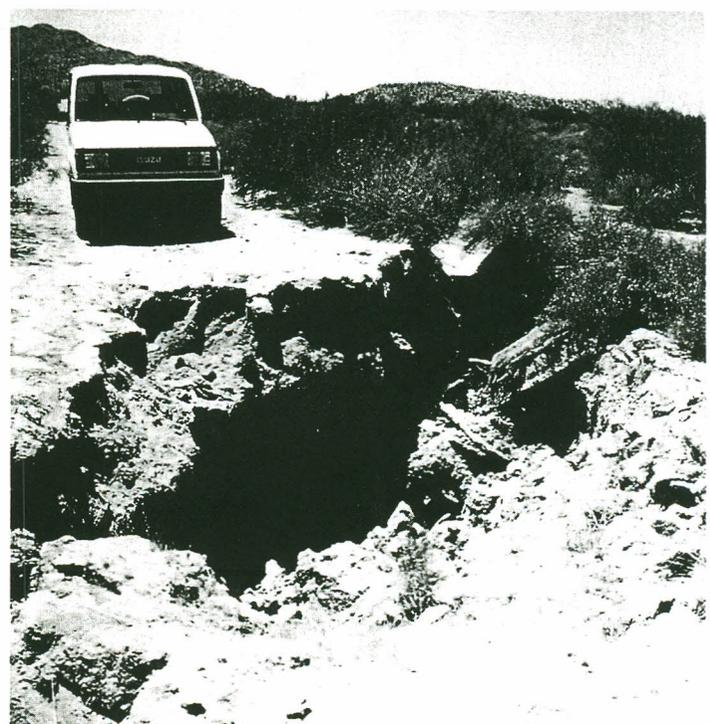
Figure 4. An earth fissure cut this road in Pinal County several miles east of Chandler Heights. Photograph by R. C. Harris.

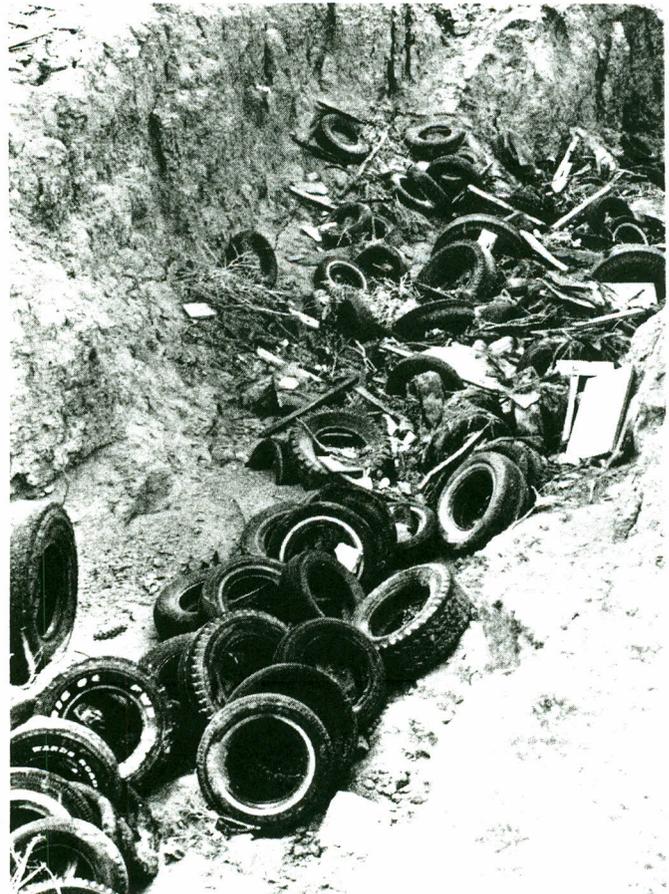
Figure 7. Earth fissures such as this one just east of the intersection of Baseline and Sossaman Road near Chandler Heights in Maricopa County are used commonly as dumps. Photograph by L. D. Fellows.

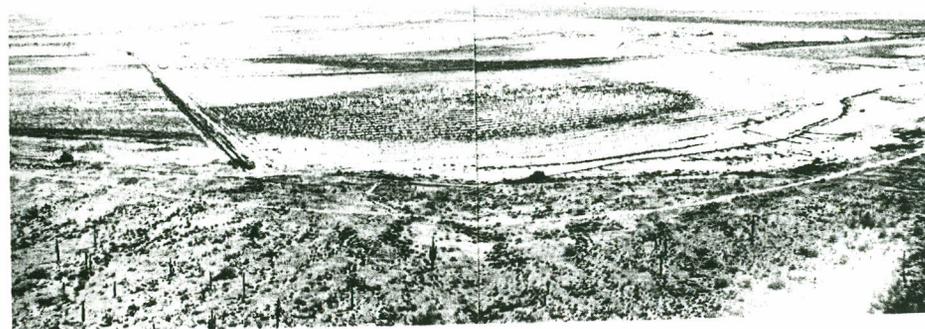
Figure 2. --View looking southeast from the Casa Grande Mountains across large pond in center of Figure 1, showing ponded rainwater in center of furrowed field and earth cracks bordering the pond.

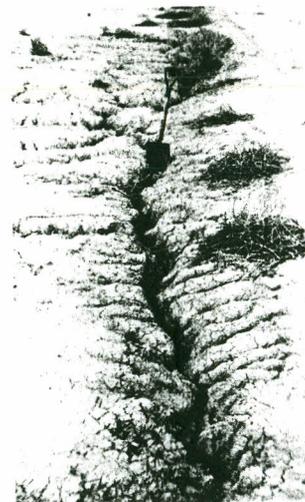
Figure 3. --Typical earth crack, showing some modification by erosion but little slumping of sides.

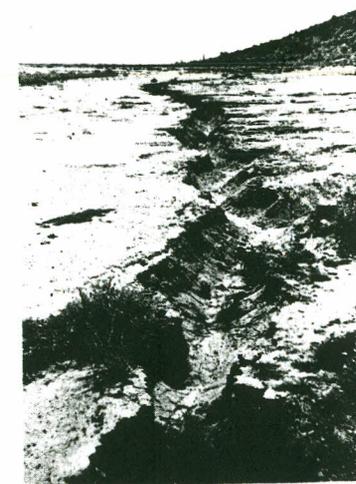
Figure 4. --Earth crack which has become wider and shallower by slumping of the sides.

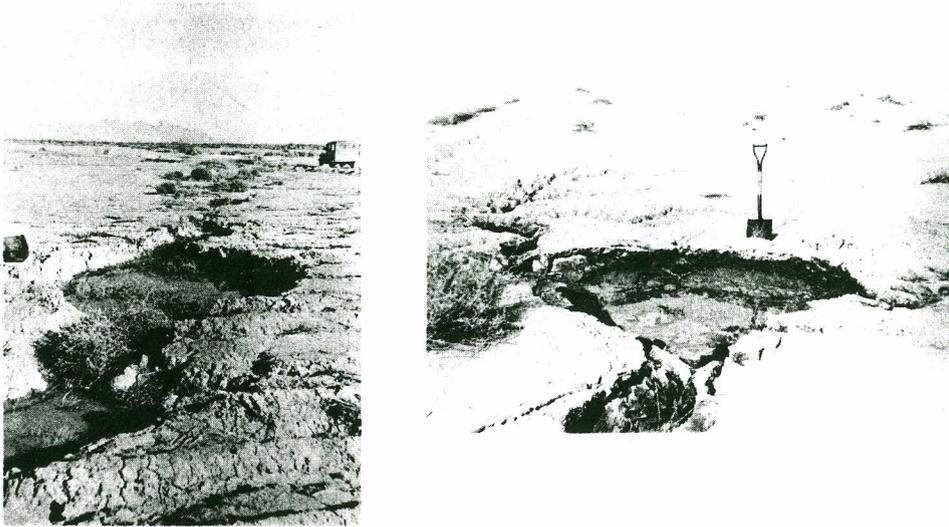
Figure 5. --Sinklike depression along an earth crack.

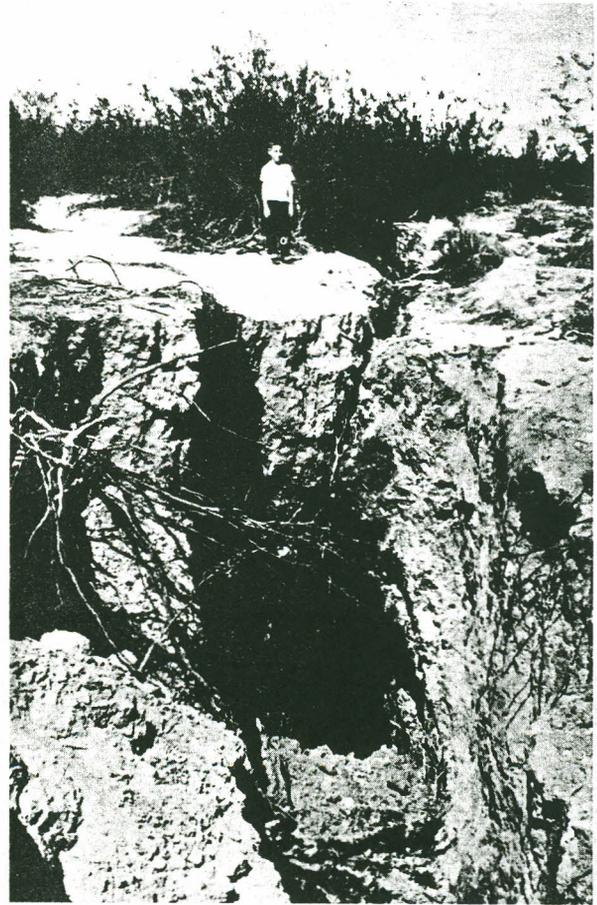
Figure 5.—Magnitude of fissure opening near Chandler Heights, viewed from site marked by arrow A in figure 4A. Photographed on September 16, 1961, by D. E. Peterson.

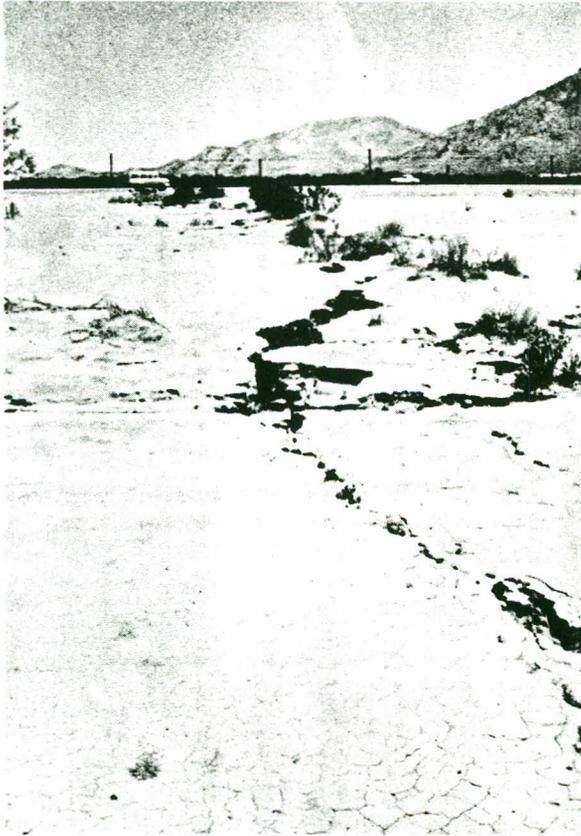
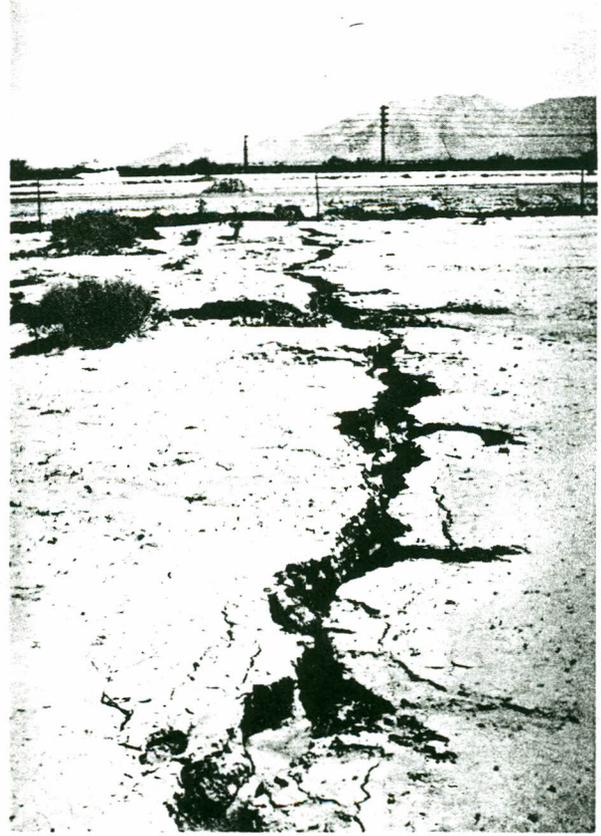
Figure 7.—Views looking northeast at fissures crossing Arizona Highway 84 near Picacho Mountains. A, Fissure 3 miles southeast of town of Picacho; 2 days previous width appeared less than half an inch; torrential rain on previous day revealed this opening; note vegetal growth along fissure. B, Fissure 1 mile southeast of Picacho. Photographs taken on August 6, 1961, by D. E. Peterson.
