FIELD GUIDE TO  
EARTH FISSURES AND OTHER  
LAND SUBSIDENCE FEATURES  
IN PICACHO BASIN

*Arizona Geological Society*  
*Arizona Hydrological Society*  
Fall 1999 Field Trip  
November 13, 1999

Arizona Geological Survey  
Open-File Report 99-26

Leader:  
Raymond C. Harris  
*Arizona Geological Survey*

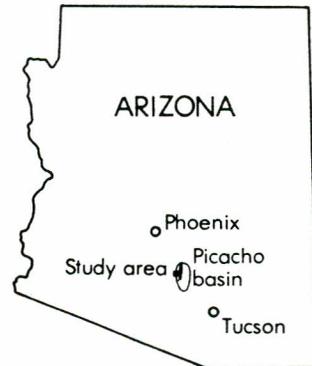
Figure 2. Map of study area (outline) and fissures as of April 11-19, 1980. Fissure zones are designated by letter. Fissures designated as active are those that formed after January 30, 1970, or showed field evidence of recent opening. Bedrock outcrop area modified from Bergquist and Blacet (1978).

Complex fissure zones and isolated straight to arcuate fissures occur in alluvium within the study area (Fig. 2). Cross-sectional form and dimensions of fissures vary greatly along individual fissures and between different fissures as well. Differences in shape and size are due primarily to modification by erosion and deposition and to the amount of tensile strain relieved by each fissure. The largest fissure examined during the time of the study was approximately 3 m wide at the surface and open to a depth of >4 m. The smallest fissures were simply hairline cracks which had not yet been modified by erosion. The activity, that is, continued horizontal movement of opposing sides by displacement, of fissures also varied from fissure to fissure and sometimes systematically along the trace of fissure zones. A few fissures appeared to be inactive, being completely or partially filled in by sediment and displaying no cracking or collapse of the sediment fill (Fig. 2). Along parts of some fissure zones studied in 1980, the presence of cracked and collapsing sediment fill in individual fissures indicated that failure is still ongoing. One of these still active fissure zones (zone C in Fig. 2) formed originally between January 1954 and February 1956, as determined by analysis of aerial photographs.

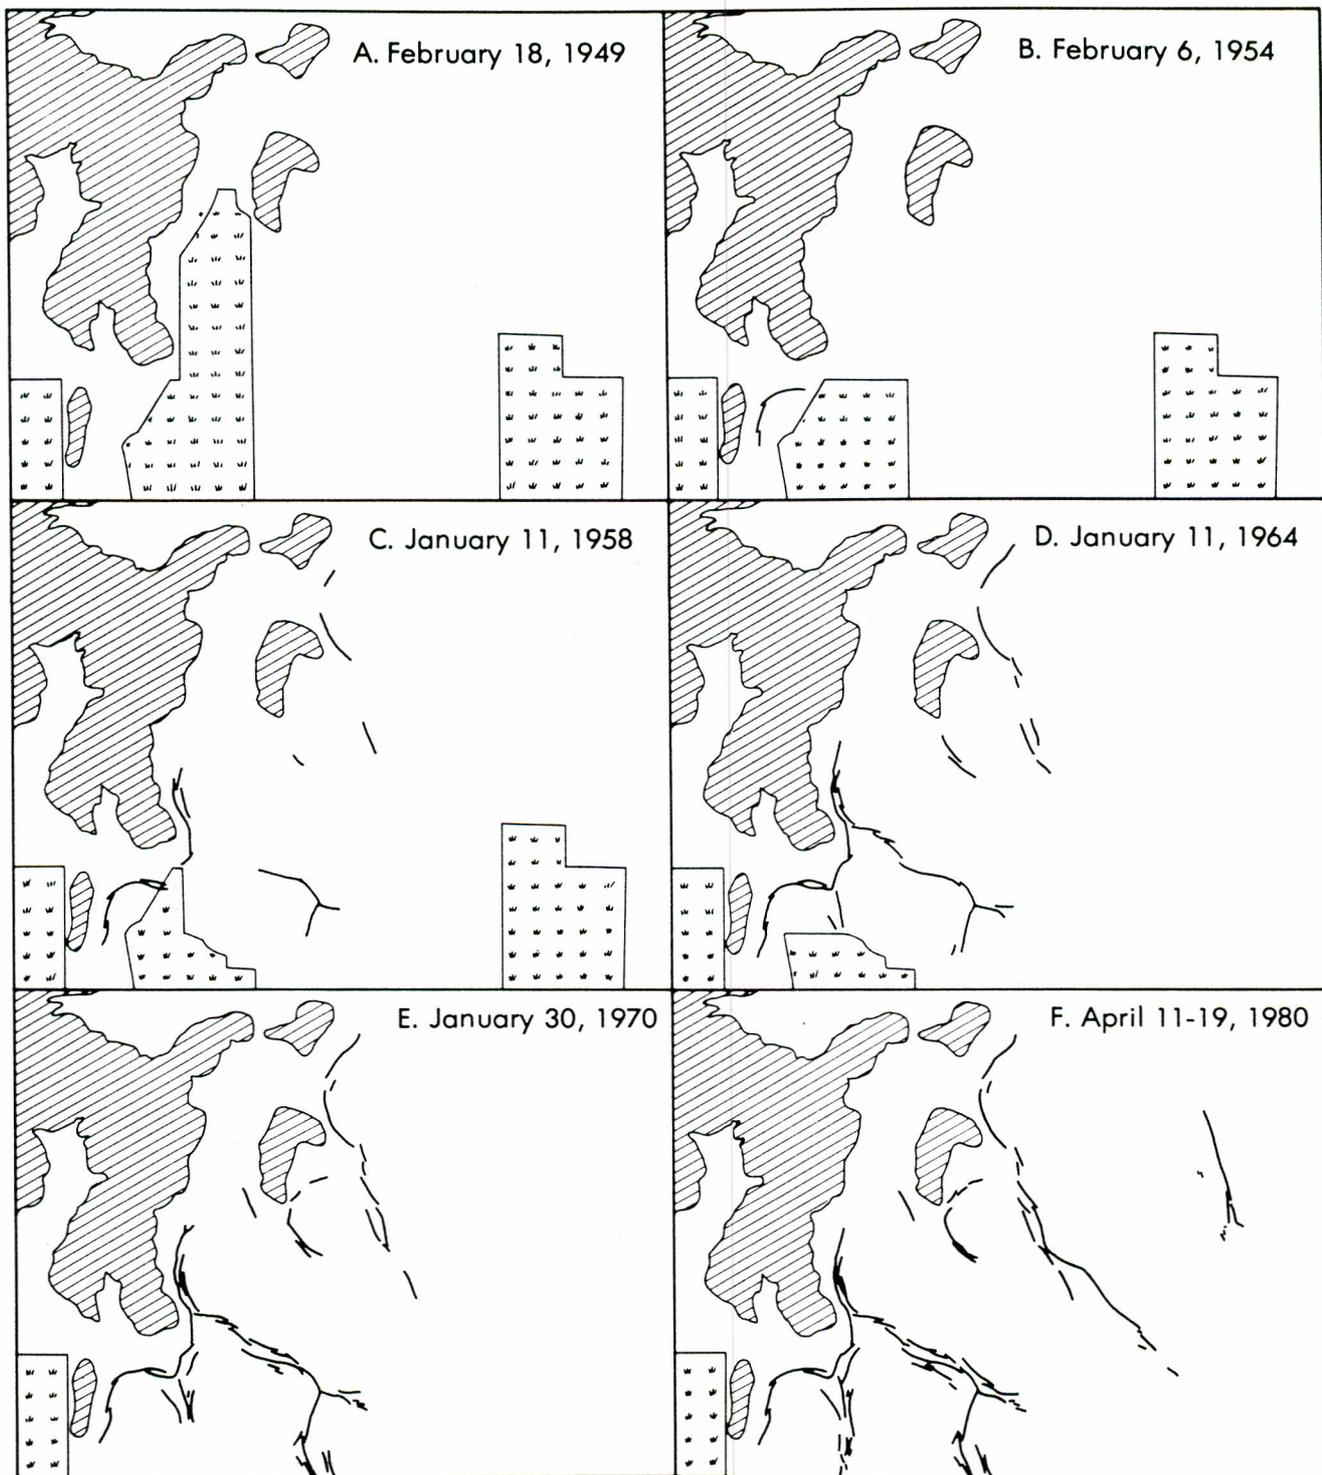
The chronology of fissure formation is shown in Figure 6. Each map, except that for April 11–19, 1980, is based on aerial photographs. The 1980 map is based on ground traverses, using an April 22, 1979, aerial photograph as a guide. Photographs taken on February 18, 1949, February 6, 1956, and in May 1972, provide additional resolution of dates of fissuring. The first fissure formed in the study area some time between February 18, 1949, and February 6, 1954. The only large-scale mapping of fissures previous to our mapping was that by Pashley (1961), who mapped fissures in part of the study area in February 1960.

Figure 6. Chronology of fissure formation and area under cultivation in study area based on interpretation of aerial photographs. Map for April 11-19, 1980, is based on ground traverses.

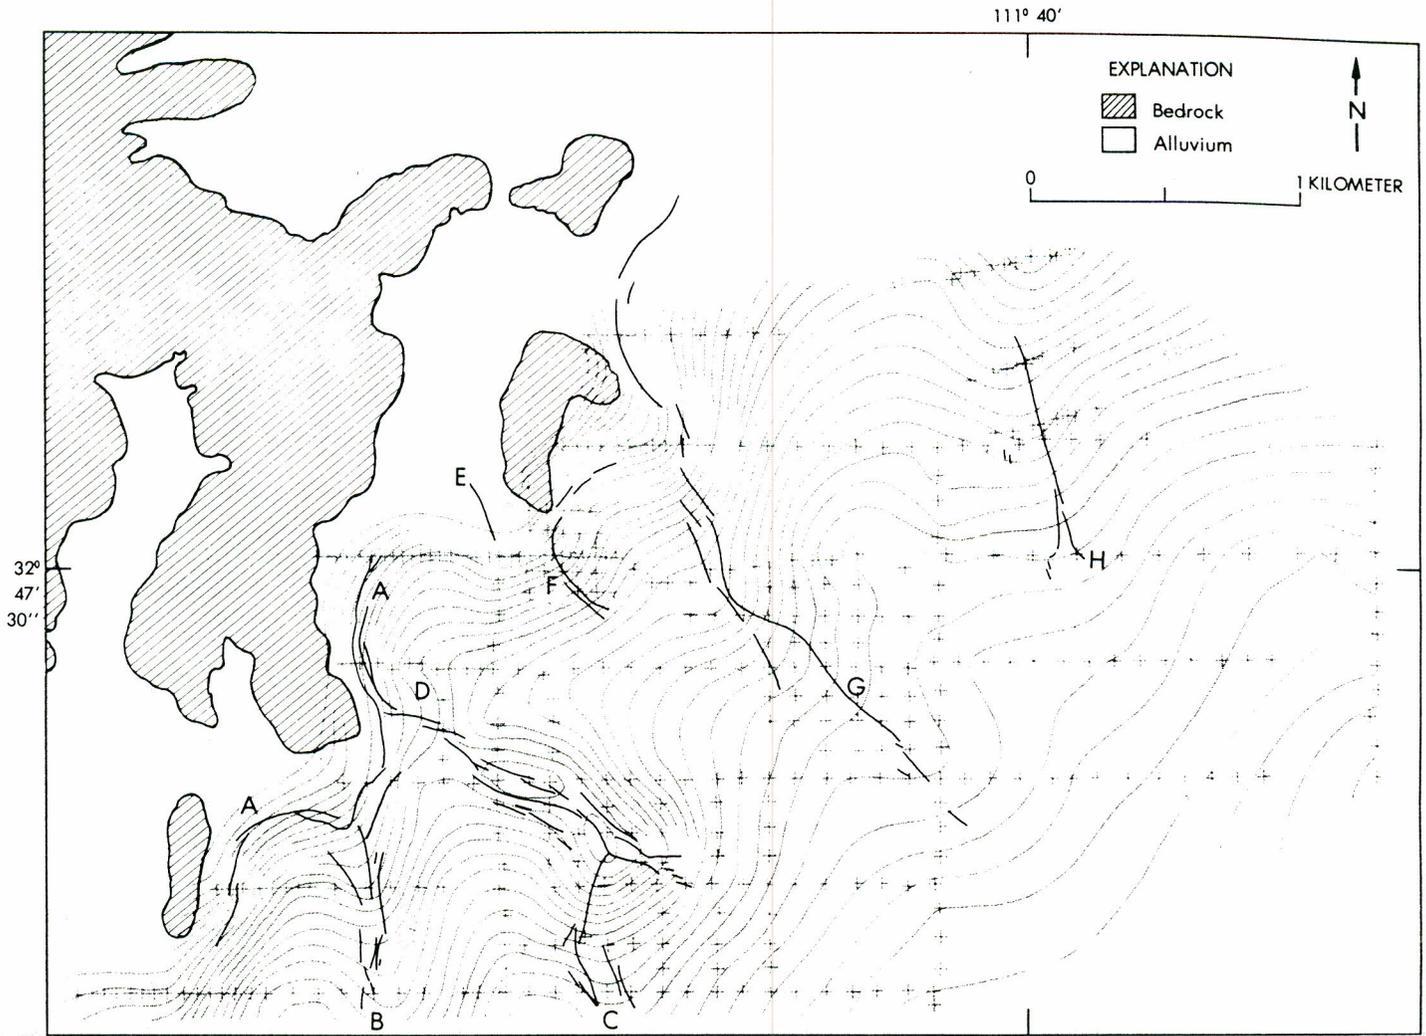
Figure 7. Relative Bouguer gravity field over the study area (Fig. 2). Contour interval is 0.2 mGal. All values have been referenced to zero at a bedrock gravity station. Crosses indicate locations of gravity measurements. Heavy lines and letters indicate fissure zones (Fig. 2). Fissures mapped during April 1980.

1978b), a striking spatial correlation exists between many local gravity anomalies and the distribution of fissures (Figs. 7 and 8). Some fissures occur along the crests of ridges in the gravity field (B, C, D, H, and parts of F and G), whereas others occur where the slope of the gravity field changes abruptly and is convex upward (A, E, and parts of F and G). For fissures in the latter category, the correlation is not obvious from the map (Fig. 7) but is readily apparent from an examination of profiles (Fig. 8), even though the change of slope is subtle at some locations (for example, lower profile in Fig. 8). The spatial correlation between convex-upward gravity anomalies and fissures can be seen along every one of the more than 20 profiles that cross fissures. No fissures occur in areas where the gravity anomalies are concave upward.

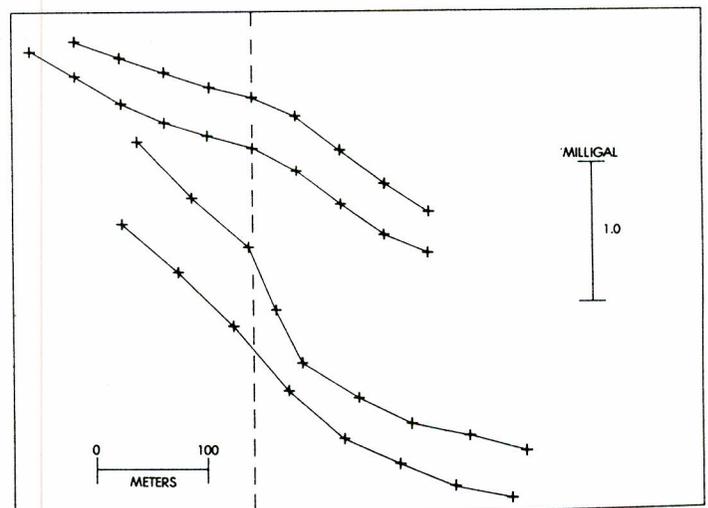
Figure 8. Local gravity anomalies along four east-west profiles that cross fissure zone A (Figs. 2, 7). Dashed line indicates location of fissure.

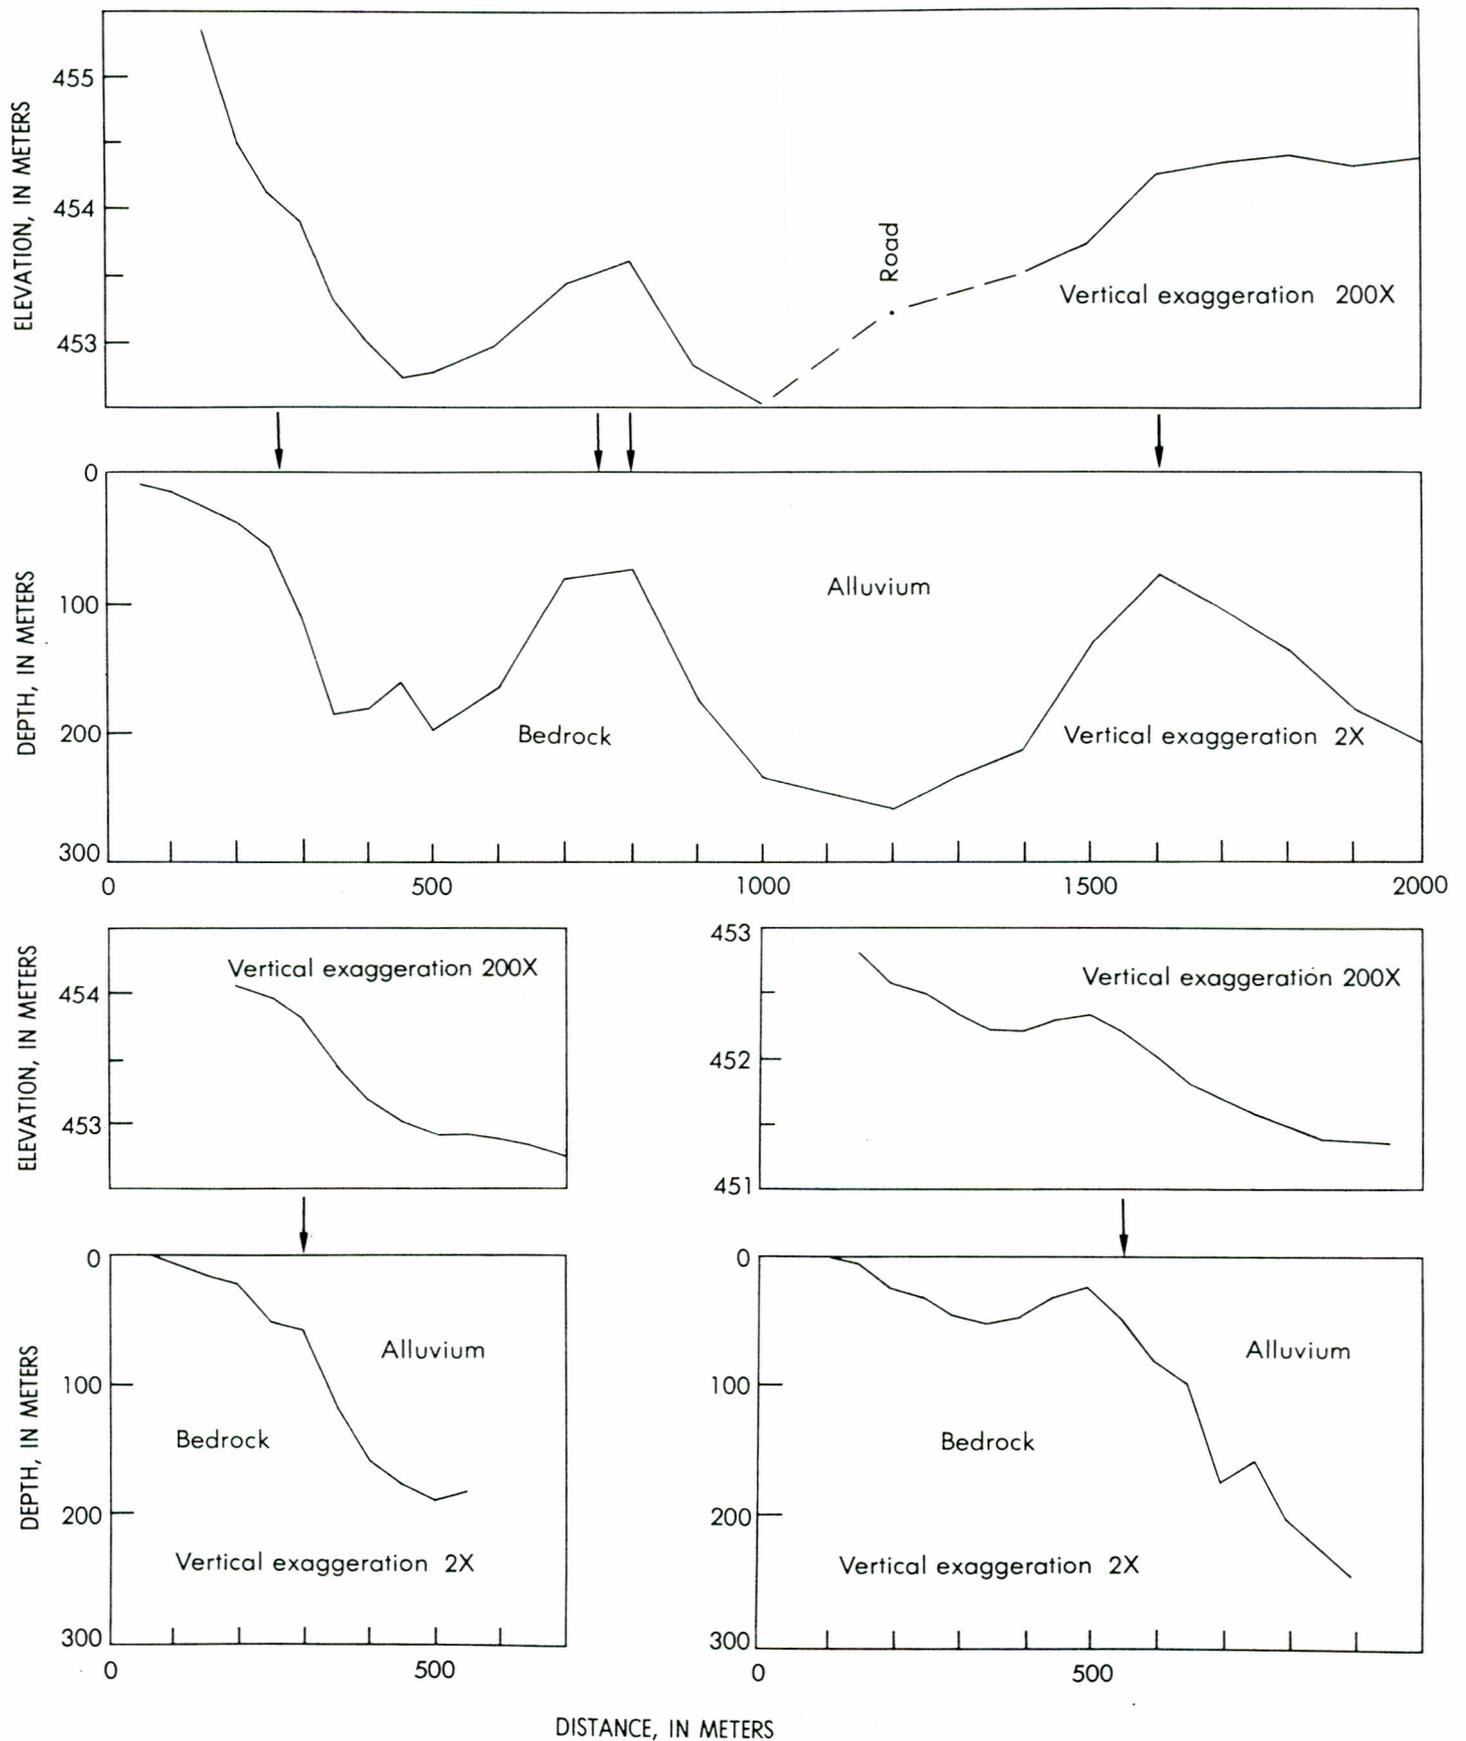
Figure 9. Surface topography in April 1980 and inferred configuration of buried bedrock surface along three profiles in study area. Arrows indicate locations of fissures.

Elevation data, collected in April 1980 for use in the gravity reductions, provided additional information relating directly to the fissures. In areas away from the steep topographic slopes associated with the mountain fronts, elevation profiles across fissures consistently show that fissures occur on local topographic highs or abrupt convex-upward breaks in slope. Several representative profiles which show this relationship are given in Figure 9.

Topographic profiles across many of these fissure zones suggest that the buried bedrock irregularities have caused localized differential subsidence because the topographic and bedrock surface profiles are similar in shape (Fig. 9). Although we have no topographic maps that show sufficient resolution for us to assess detailed pre-1948 topography, comparison of the buried local relief across specific bedrock features with the relief on the corresponding topographic profiles suggests that the origin of the topographic relief is related to ground-water withdrawal. The average ratio of differential subsidence, assumed to be equal to the local topographic relief, to differential thickness, equal to bedrock relief, determined from six profiles, was 0.0092 (Table 1). This ratio agrees well with the compaction per saturated thickness of 0.0083 determined at bench mark Guano using borehole and leveling data. In addition, the small range of values of the ratio, 0.0081 to 0.0108, and the

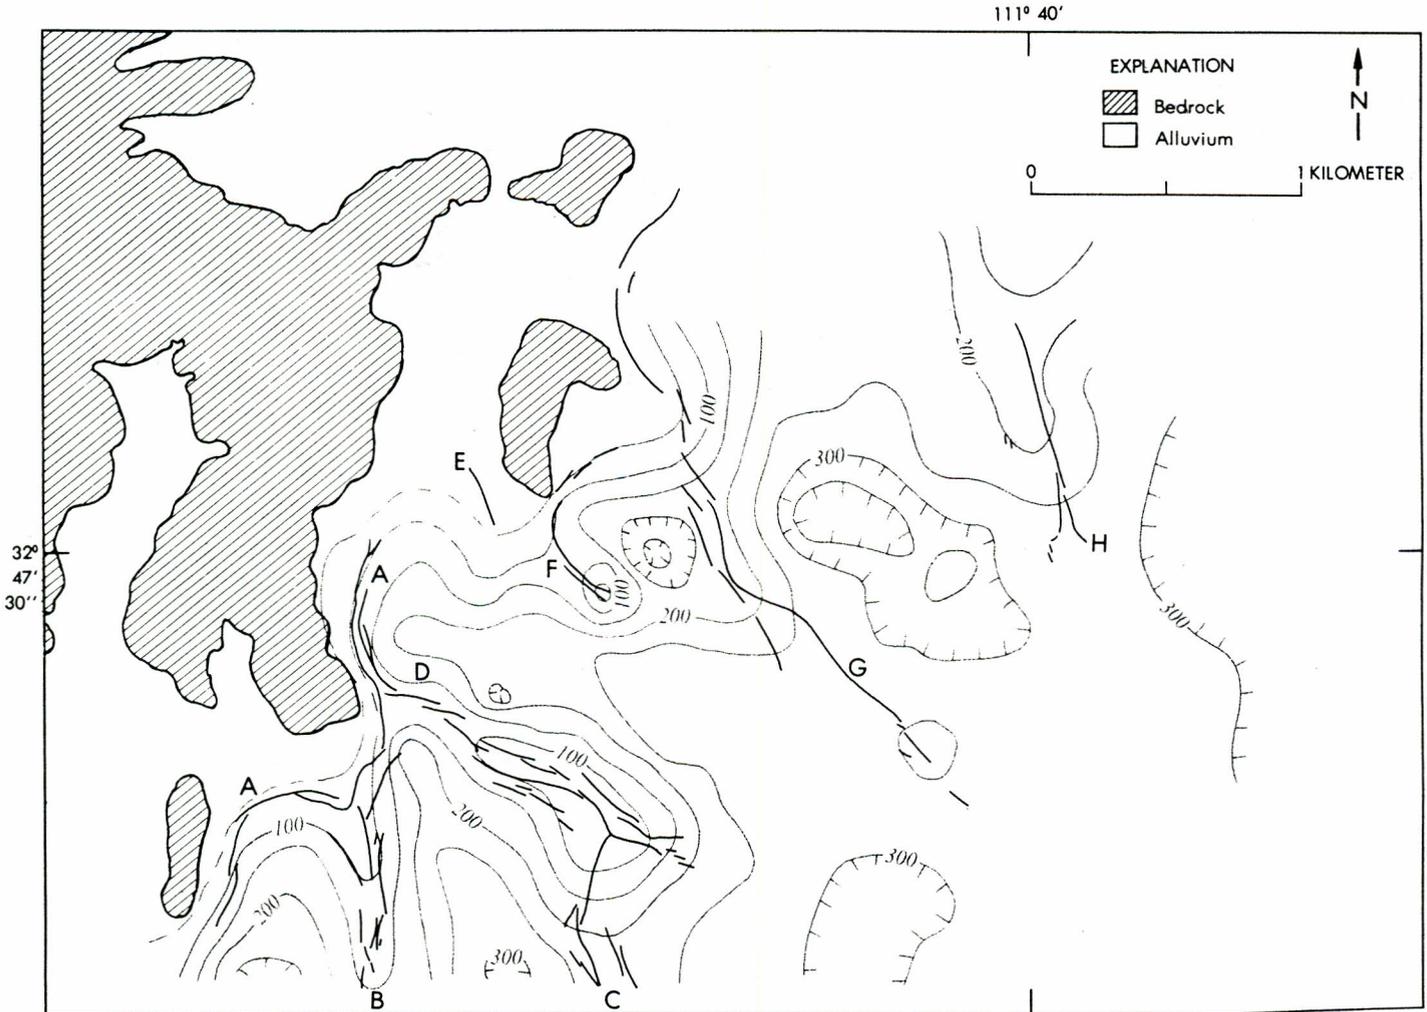
Figure 10. Map of inferred depth in metres to bedrock beneath land surface. Contour interval is 50 m. Fissures mapped during April 1980; see Figure 2 for location. Hachures on contours point in direction of increasing depth.

Comparison of the distribution of fissures with the inferred configuration of the bedrock surface (Fig. 10) reveals that earth fissures in the study area are associated with relief on the interface between the bedrock and the alluvium. Fissure zones B, C, D, E, F (south half), G, and H all occur almost directly over the crests of buried bedrock ridges. Three crossings of the other fissure zone, A, show that it occurs above an abrupt, convex-upward change of slope of the bedrock surface (Fig. 11A). The bedrock control is particularly striking at junctions between fissure zones such as occur in the southwestern part of the study area. There, the angles of intersection of fissure zones B and D with A accurately reflect the

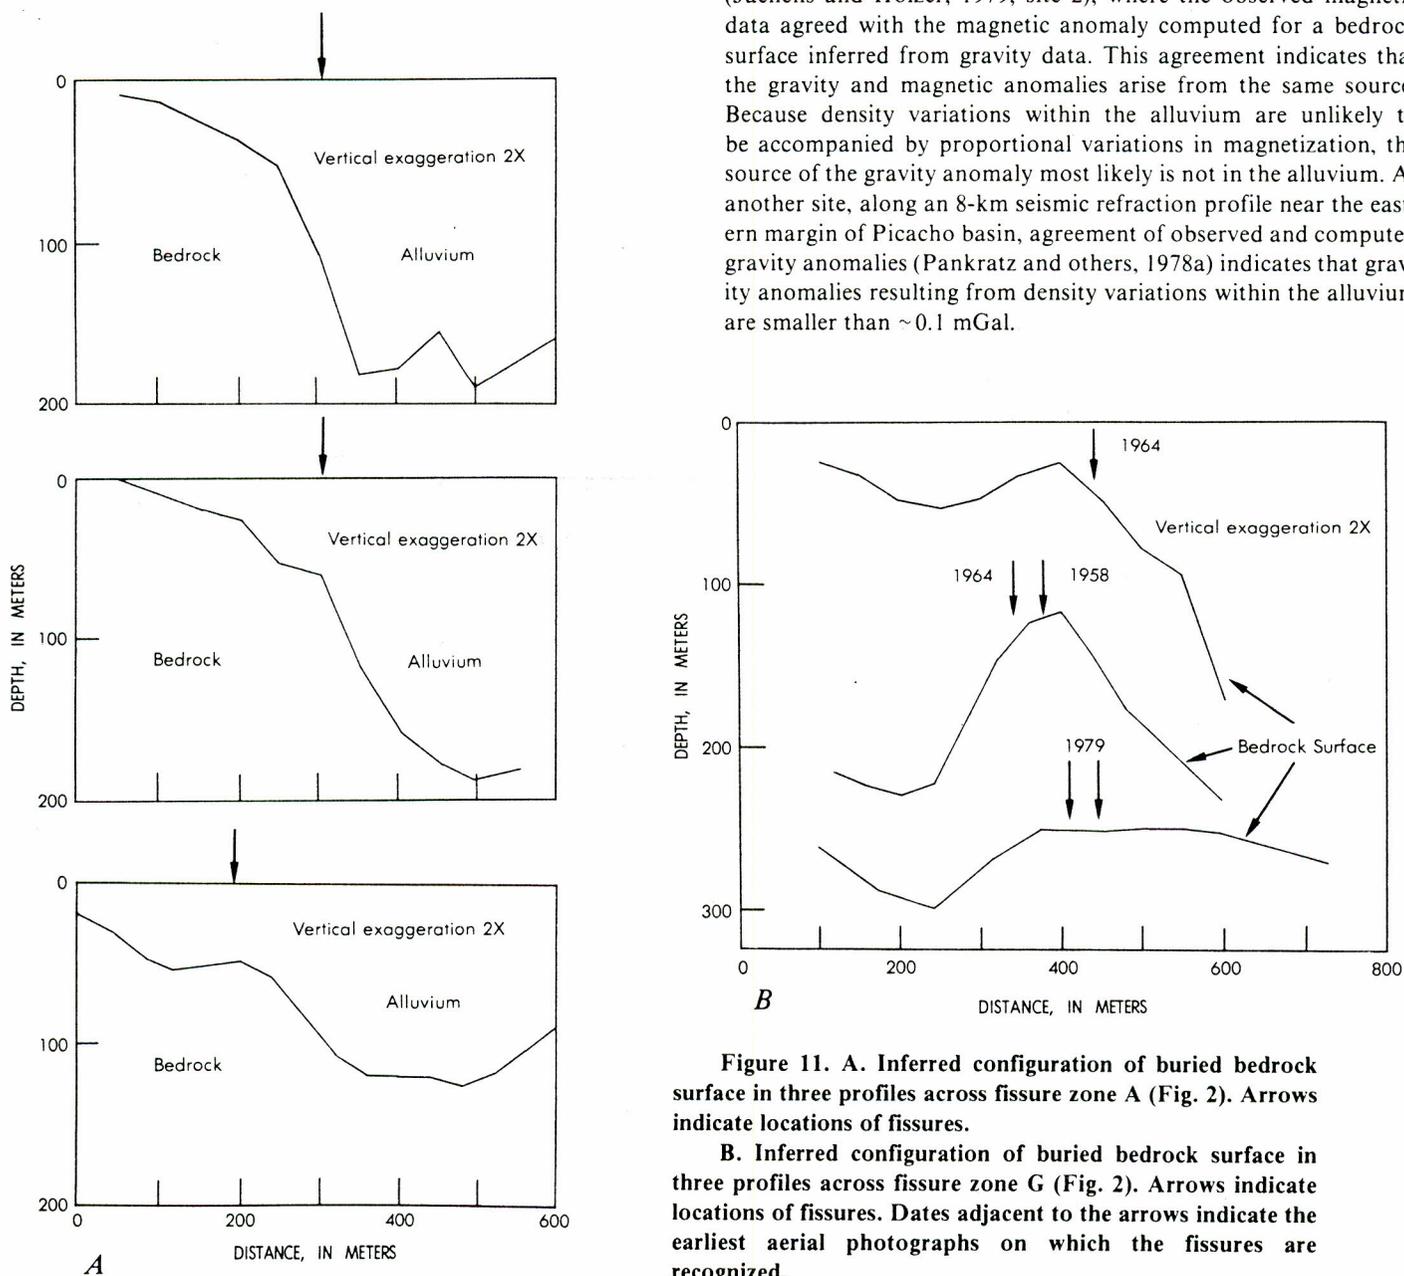
Figure 11. A. Inferred configuration of buried bedrock surface in three profiles across fissure zone A (Fig. 2). Arrows indicate locations of fissures.

B. Inferred configuration of buried bedrock surface in three profiles across fissure zone G (Fig. 2). Arrows indicate locations of fissures. Dates adjacent to the arrows indicate the earliest aerial photographs on which the fissures are recognized.

More precise estimates of the configuration of the bedrock surface beneath selected earth fissures, based on two-dimensional modeling of gravity profiles, indicate that, in general, fissures in the study area occur above points of maximum convex-upward curvature of the bedrock surface (Figs. 9 and 11). Horizontal distances between points of maximum curvature and locations of fissures were generally within the limits of resolution determined by the spacing between gravity measurements.

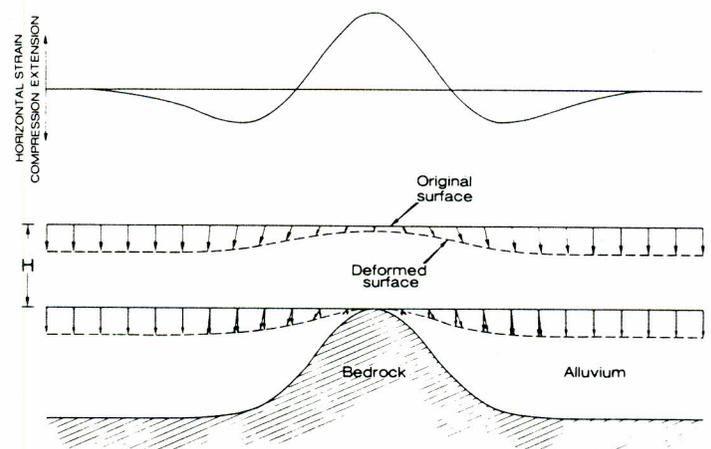
The strongest evidence supporting this mechanism of fissure formation is the location of earth fissures in the study area at and above points of maximum convex-upward curvature in the topographic profiles and buried bedrock surface, respectively. According to Lee and Shen (1969), horizontal strains caused by differential compaction are tensile where subsidence profiles are convex-upward, and tension is greatest at points of maximum convex-upward curvature in the profiles (Fig. 12). Tensile failure, of course, would be most likely at points of maximum tension.

Figure 12. Schematic drawing of the proposed model for fissure formation in study area. Differential vertical displacements acting on base of layer (heavy arrows) are caused by differential compaction caused by variations of alluvial thickness. Light arrows indicate displacements resulting from vertical displacements imposed at base of layer. Thickness,  $H$ , of layer is equal to depth from land surface to highest point on buried bedrock features. Horizontal strains at land surface caused by displacements at base of layer are shown at top of figure.

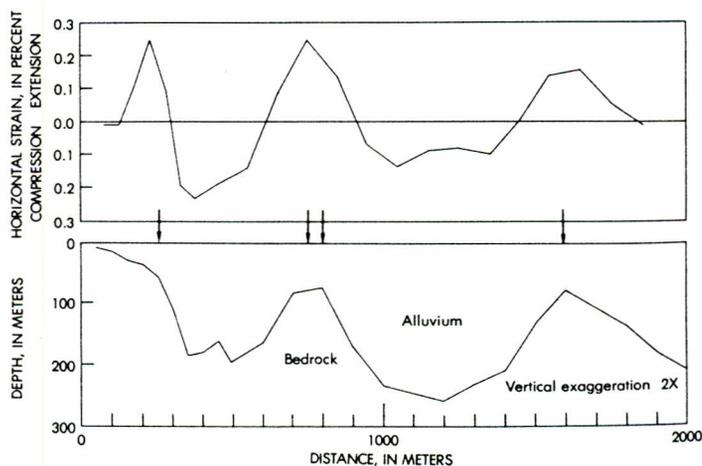
Figure 13. Computed horizontal surface strain (1980) and inferred configuration of buried bedrock surface beneath an east-west profile across fissure zones A, B, and C (Fig. 2). Arrows indicate locations of fissures.

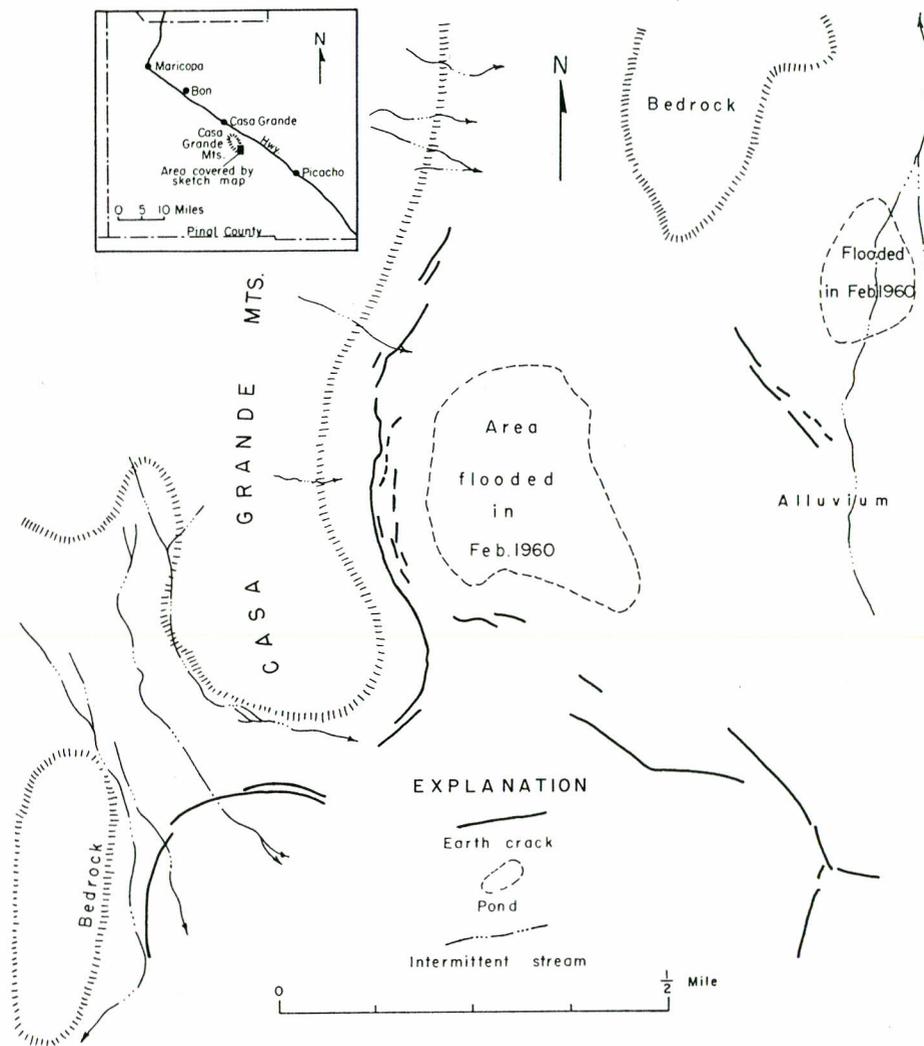
Figure 1. —Sketch map showing pattern of earth cracks at the southeast corner of the Casa Grande Mountains, February 1960.

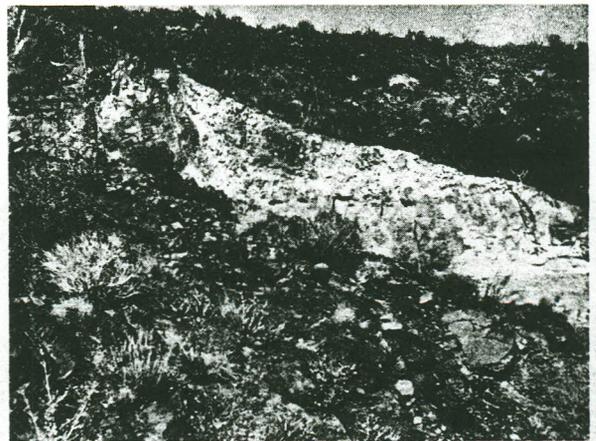
A

Figure 3.—Ground views of uppermost and lowermost principal fissures near Black Canyon. A, View looking north at vertical displacement near east end of slippage fault produced by upper fissure. B, View looking west at size of opening near western end of lower fissure. Photographs taken on February 3, 1962, by H. T. Chapman.

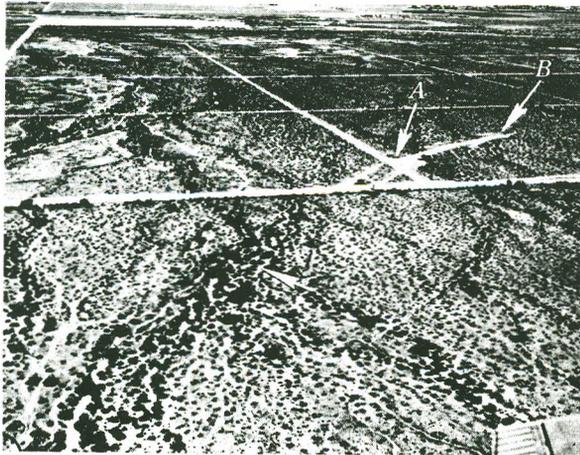
A

Figure 4.—Aerial views looking north at fissure near Chandler Heights. A, General view of the area with arrows denoting fissure trace. B, Closer view of fissure trace with same saguaro cactus circled. Photographs taken on February 10, 1962, by H. T. Chapman and A. E. Robinson.

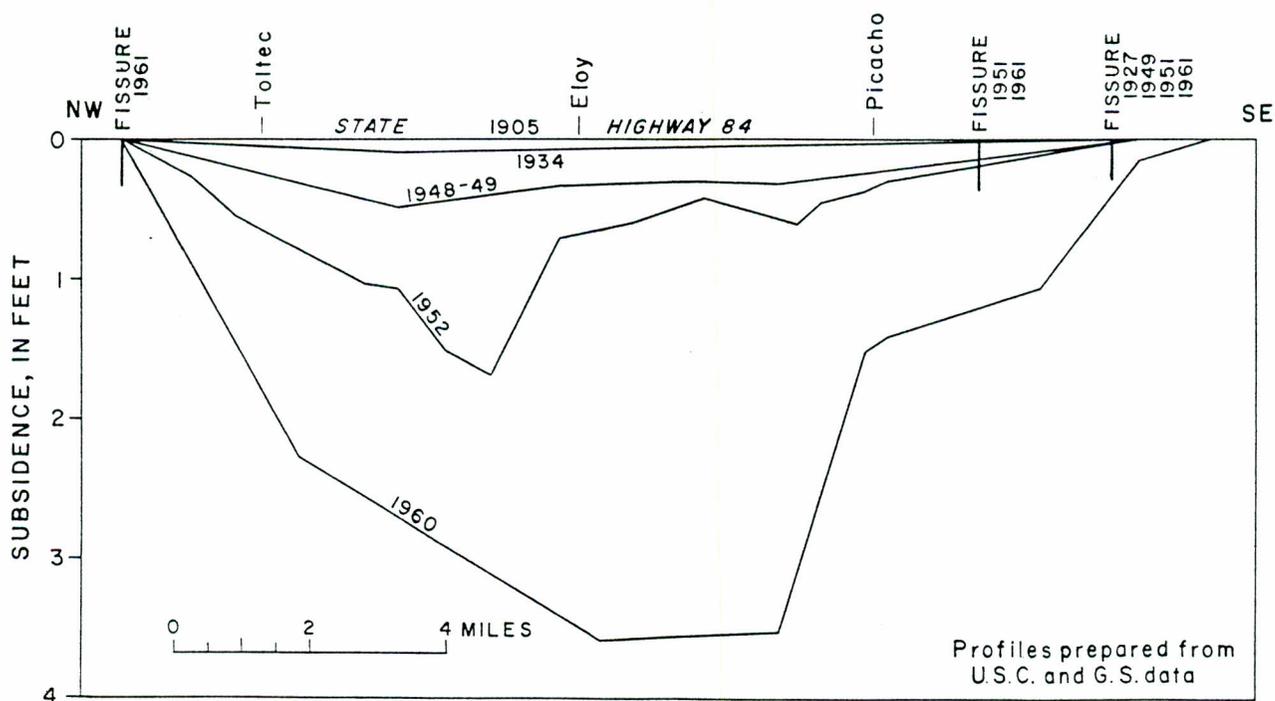
Also shown in figure 6 are the points at which several observed earth fissures intersect the profile along Arizona Highway 84. As might be expected, the fissures are near the outer limits of the subsidence profiles where the earth material could have been subjected to tensile stresses.

The fissure shown at the extreme right in figure 6, at a point on Highway 84 about 3 miles southeast of Picacho, is the one described by Leonard (1929) as having first opened in September 1927. Subsequent filling and reopening of this and other fissures in the general area are described by Heindl and Feth (1955). Leonard's description mentions the fissure length as one-fourth mile; it is now at least 8 miles long. Part of the fissure appears in a photograph (fig. 7A) taken on August 6, 1961, looking northeast across

Figure 6.—Changes in land-surface elevation in the Eloy-Picacho area, Pinal County, Arizona.
